1980 C.B. ANNUAL REPORT

SUMMARY OF DEVELOPMENT ACTIVITIES,
COSTS AND ENVIRONMENTAL MONITORING

CATHEDRAL BLUFFS SHALE OIL COMPANY
TENNECO SHALE OIL COMPANY
OCCIDENTAL OIL SHALE INC., OPERATOR

APRIL 30, 1981

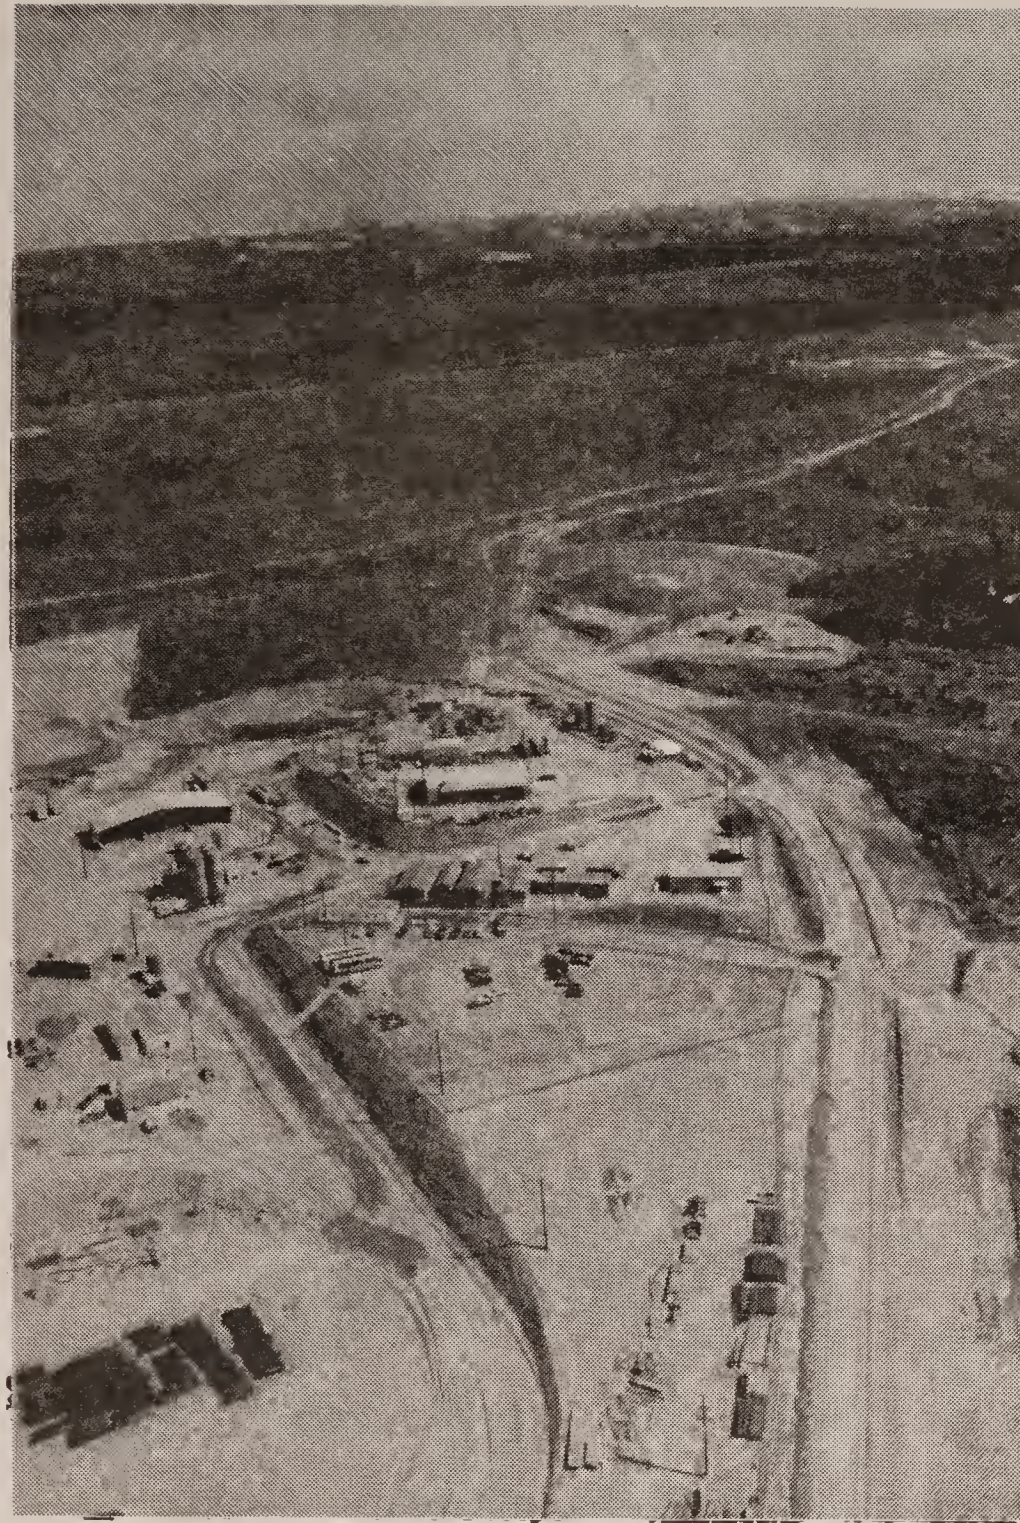
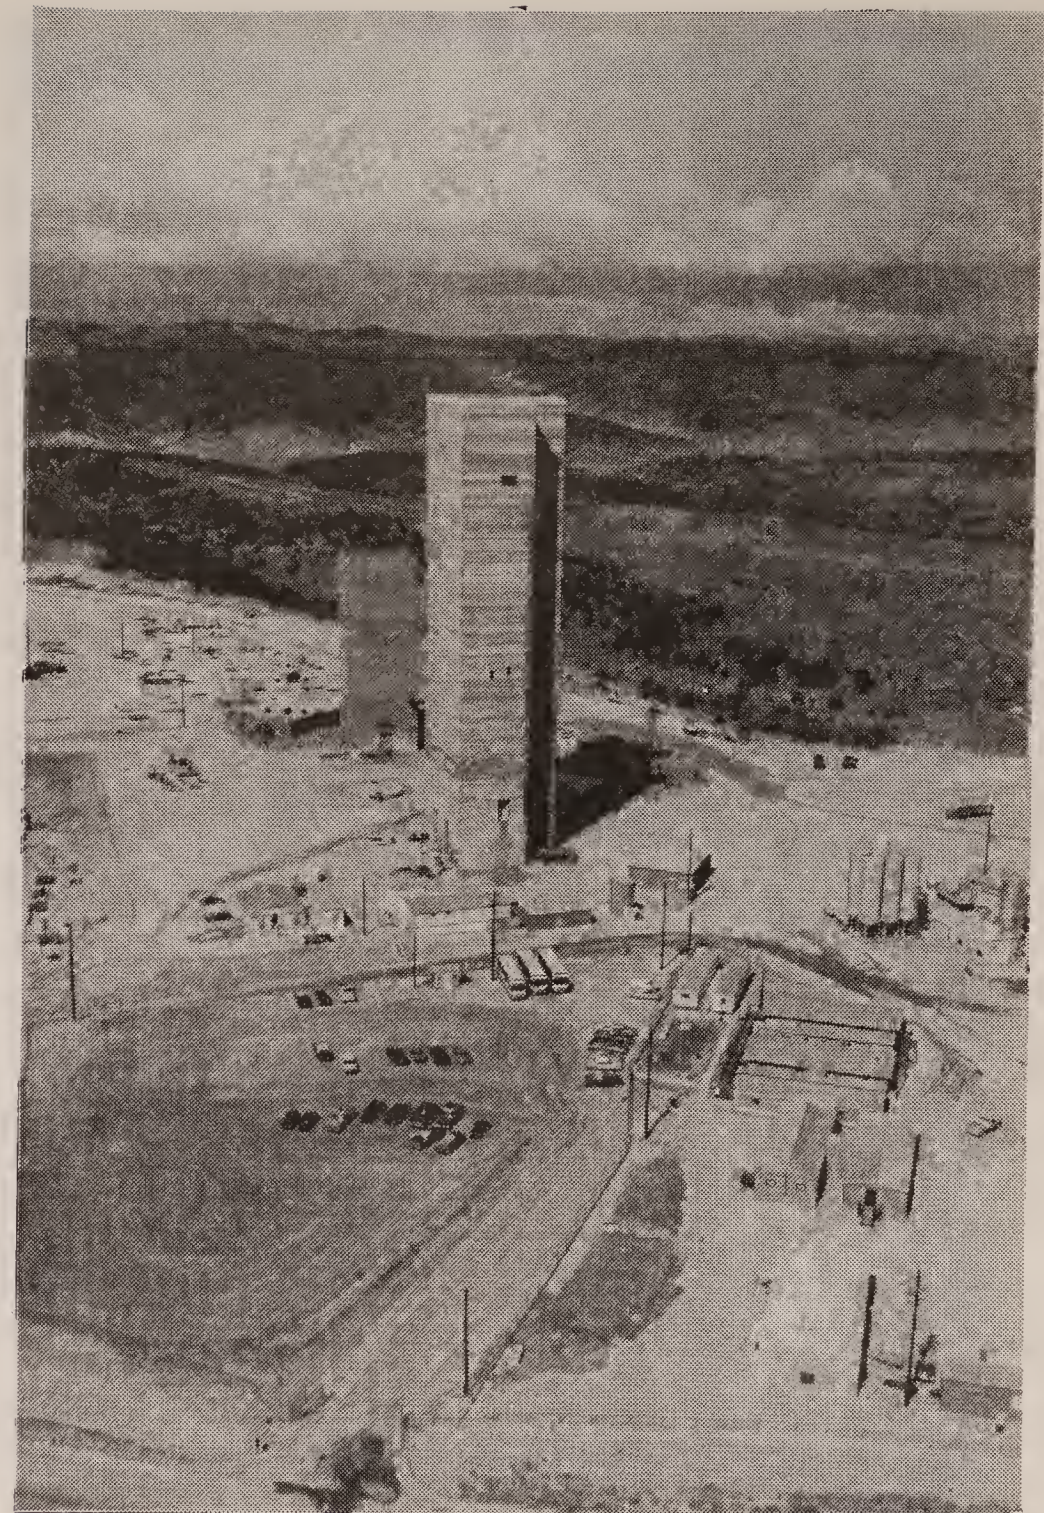
Figure 4-7 Aerial Views of the Mine Support Area (April 1980)

a) SOUTH VIEW

b) NORTH VIEW

Most activities occurred near the mine support area for which aerial views are shown on Figures 4-7a and 4-7b. The view looking northward (Figure 4-7b) is repeated with a side-by-side portion of a tract map identifying the facilities on Figure 4-8, utilizing the same facility numbers as on Table
